**US Army Corps
of Engineers**

CERL Technical Report 99/66
August 1999

Technical Assistance To Supplement Installation of Low NO_x Boilers at the Pentagon Heating and Refrigeration Plant

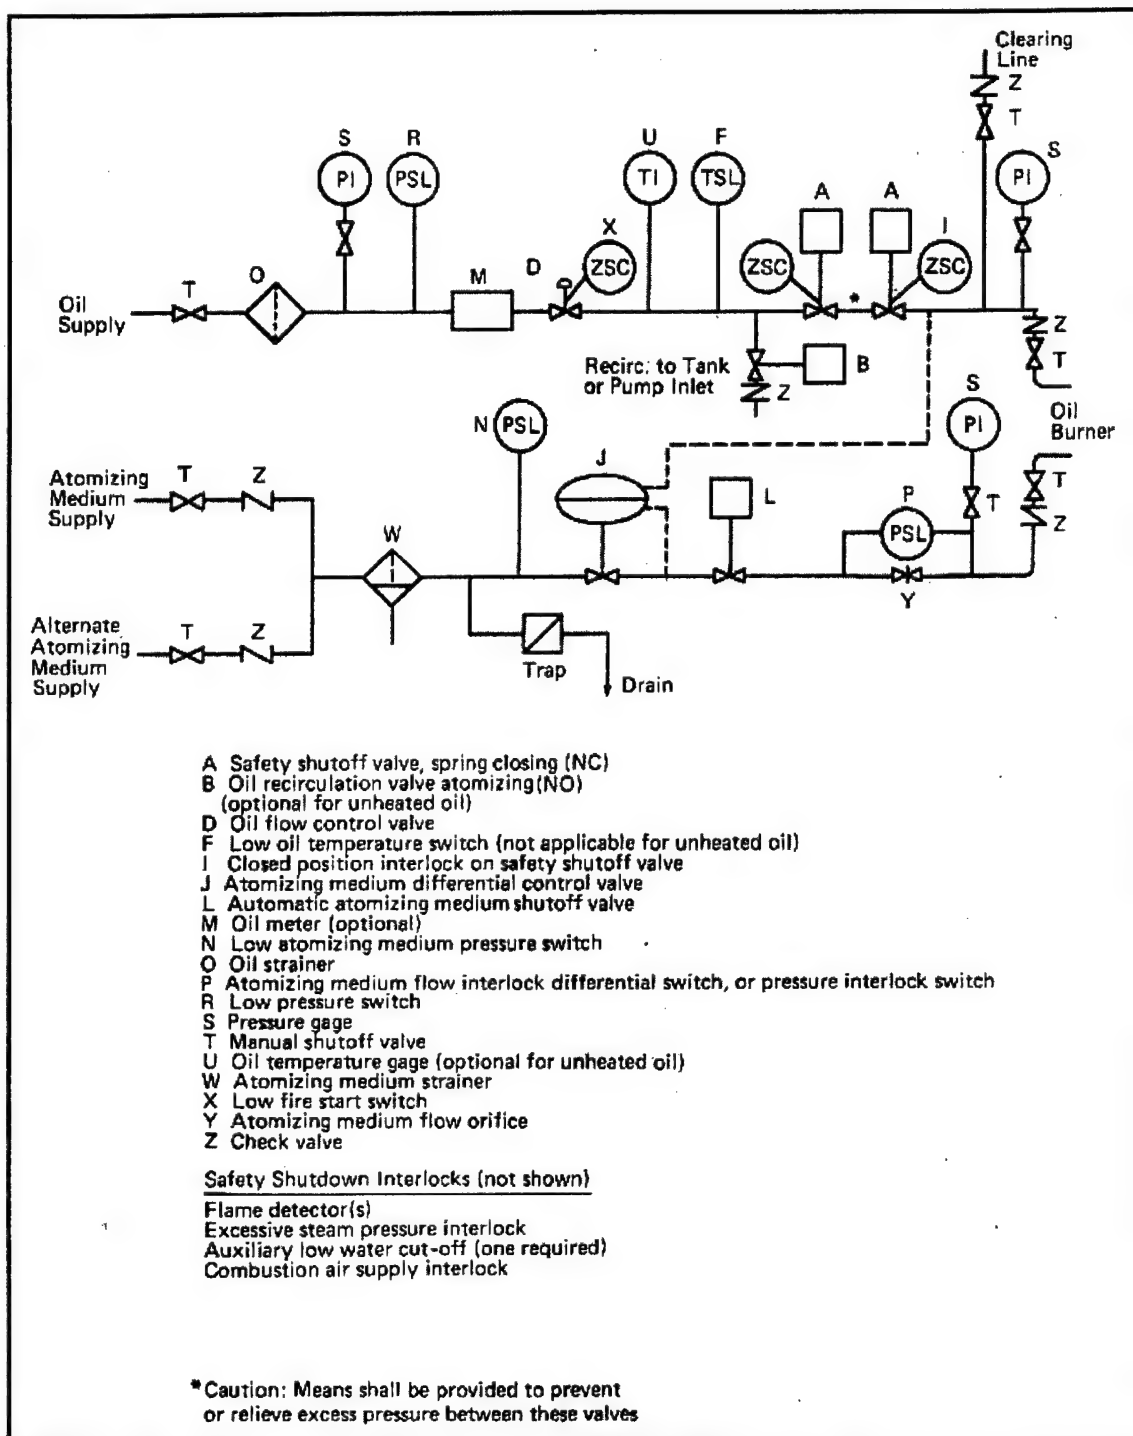
Figure 11. Typical fuel and atomization medium systems and safety controls for the burner (from NFPA 8501, Figure A-4-1.8).
